Maintain a copy of this form and any documentation provided with the insurance policy

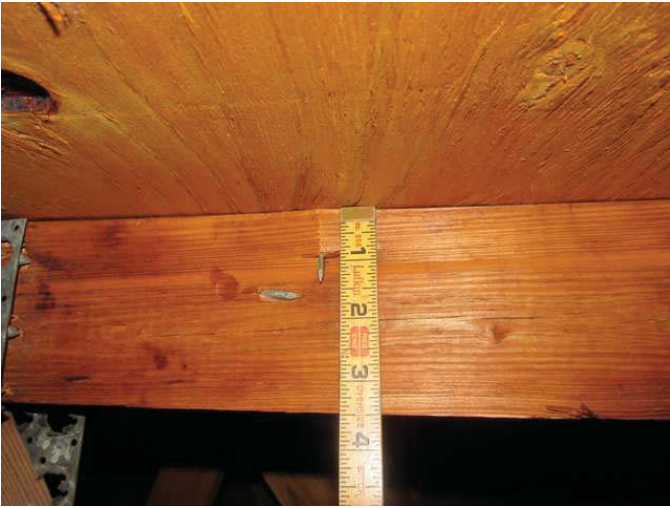
- A. Plywood/Oriented strand board (OSB) roof sheathing attached to the roof truss/rafter (spaced a maximum of 24" inches o.c.) by staples or 6d nails spaced at 6" along the edge and 12" in the field. -OR- Batten decking supporting wood shakes or wood shingles. -OR- Any system of screws, nails, adhesives, other deck fastening system or truss/rafter spacing that has an equivalent mean uplift less than that required for Options B or C below.

6D Nails

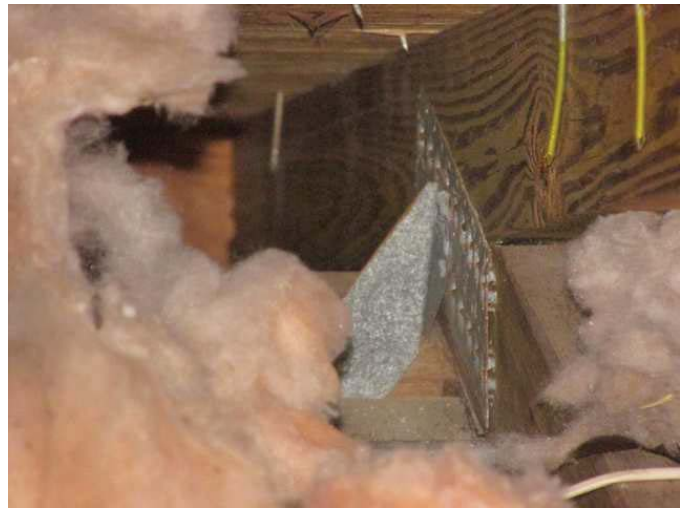
- B. Clips
 - Metal connectors that do not wrap over the top of the truss/rafter, **or**
 - Metal connectors with a minimum of 1 strap that wraps over the top of the truss/rafter and does not meet the nail position requirements of C or D, but is secured with a minimum of 3 nails.

Clips with a minimum of 3 nails
