Maintain a copy of this form and any documentation provided with the insurance policy

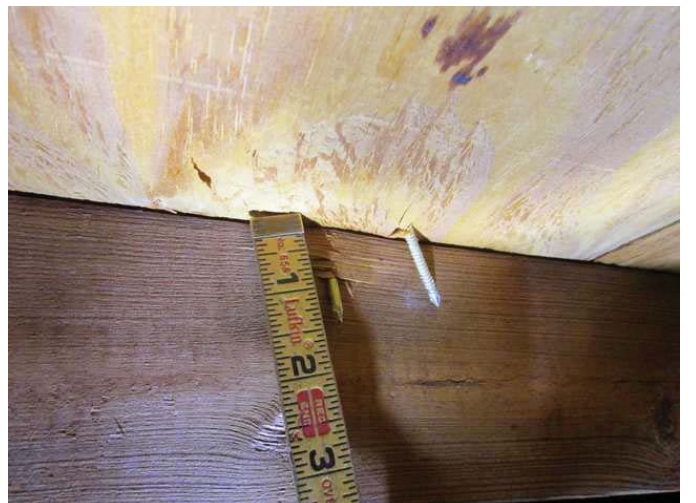
- A. Plywood/Oriented strand board (OSB) roof sheathing attached to the roof truss/rafter (spaced a maximum of 24" inches o.c.) by staples or 6d nails spaced at 6" along the edge and 12" in the field. -OR- Batten decking supporting wood shakes or wood shingles. -OR- Any system of screws, nails, adhesives, other deck fastening system or truss/rafter spacing that has an equivalent mean uplift less than that required for Options B or C below.

6D Nails

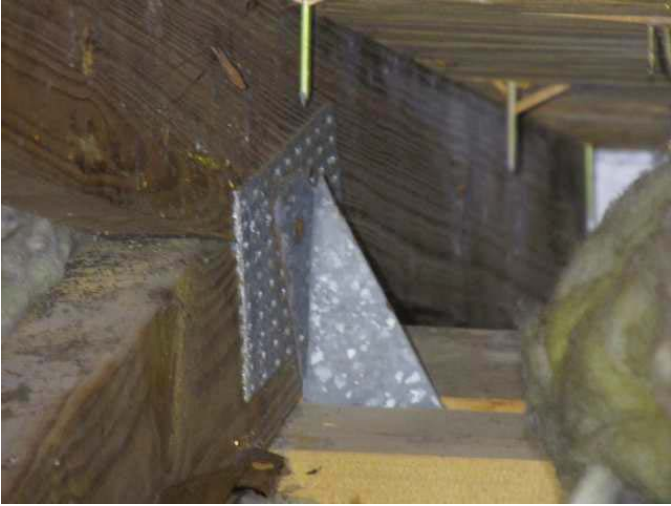
- B. Clips
 - Metal connectors that do not wrap over the top of the truss/rafter, **or**
 - Metal connectors with a minimum of 1 strap that wraps over the top of the truss/rafter and does not meet the nail position requirements of C or D, but is secured with a minimum of 3 nails.
- C. Single Wraps

Clips with a minimum of 3 nails
