Uniform Mitigation Verification Inspection Form

Inspection Date: 05/24/2017		
Owner Information		
Owner Name: Banana Bay Condominium Association		Contact Person:
Address: 200 S Banana River Blvd Building 2100		Home Phone:
City: Cocoa Beach	Zip: 32931	Work Phone:
County: Brevard		Cell Phone:
Insurance Company:		Policy #:
Year of Home: 1974	# of Stories: 2	Email:

Inspectors Initials JS Property Address 200 S Banana River Blvd Building 2100 Cocoa Beach

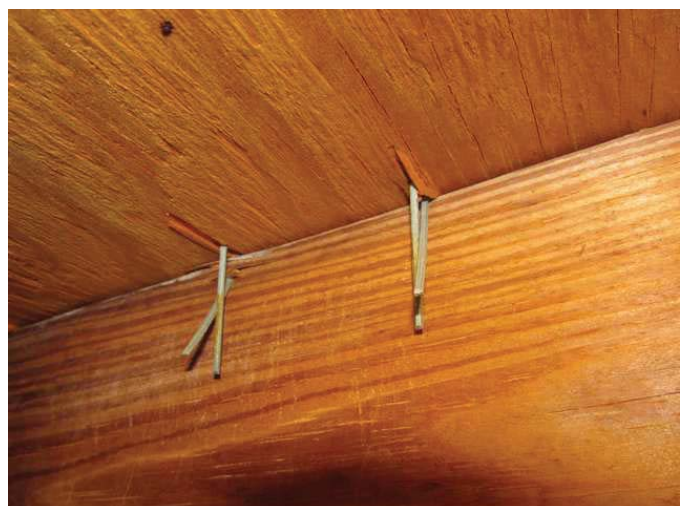
- A. Plywood/Oriented strand board (OSB) roof sheathing attached to the roof truss/rafter (spaced a maximum of 24" inches o.c.) by staples or 6d nails spaced at 6" along the edge and 12" in the field. -OR- Batten decking supporting wood shakes or wood shingles. -OR- Any system of screws, nails, adhesives, other deck fastening system or truss/rafter spacing that has an equivalent mean uplift less than that required for Options B or C below.

Staples

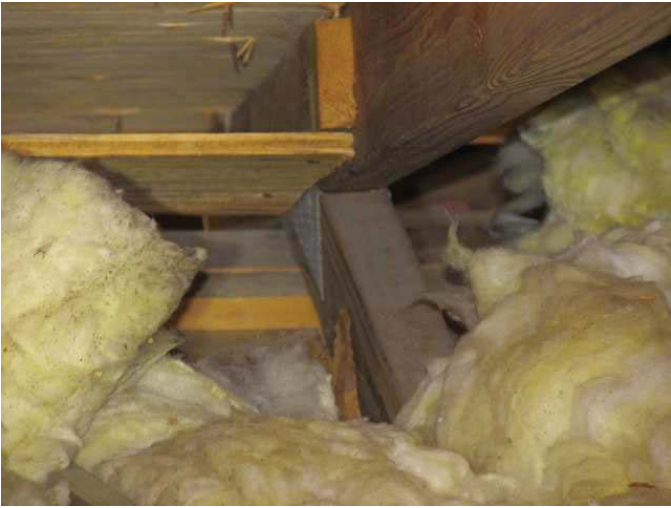
- A. Toe Nails
 - Truss/rafter anchored to top plate of wall using nails driven at an angle through the truss/rafter and attached to the top plate of the wall, or
 - Metal connectors that do not meet the minimal conditions or requirements of B, C, or D

Toe Nails

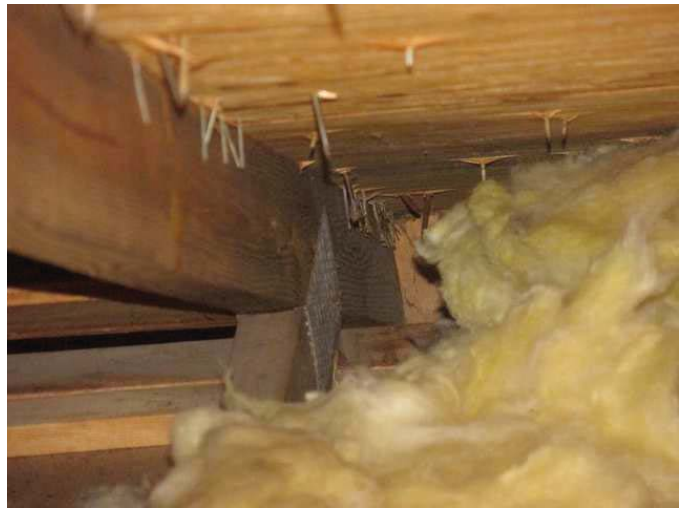
Toe Nails
