Uniform Mitigation Verification Inspection Form

Inspection Date: 05/24/2017		
Owner Information		
Owner Name: Banana Bay Condominium Association		Contact Person:
Address: 200 S Banana River Blvd Building 900		Home Phone:
City: Cocoa Beach	Zip: 32931	Work Phone:
County: Brevard		Cell Phone:
Insurance Company:		Policy #:
Year of Home:	# of Stories: 2	Email:

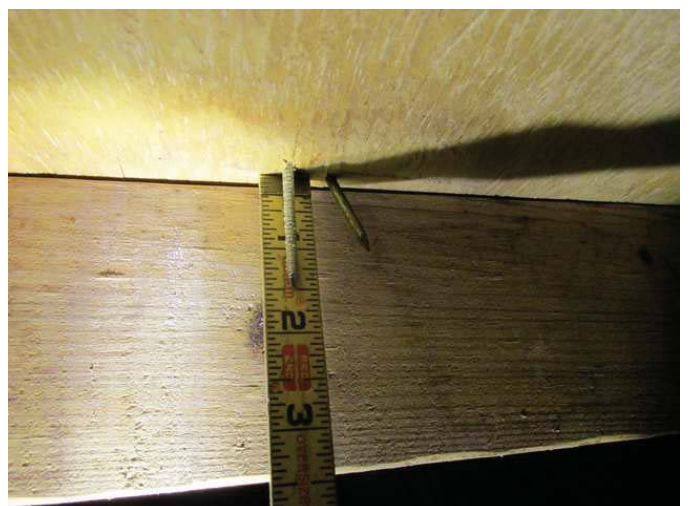
- A. Plywood/Oriented strand board (OSB) roof sheathing attached to the roof truss/rafter (spaced a maximum of 24" inches o.c.) by staples or 6d nails spaced at 6" along the edge and 12" in the field. -OR- Batten decking supporting wood shakes or wood shingles. -OR- Any system of screws, nails, adhesives, other deck fastening system or truss/rafter spacing that has an equivalent mean uplift less than that required for Options B or C below.

6D Nails
