Uniform Mitigation Verification Inspection Form

Inspection Date: 03/06/2017		
Owner Information		
Owner Name: Village Square of Titusville Condo		Contact Person:
Address: 1715 Harrison St		Home Phone:
City: Titusville	Zip: 32780	Work Phone:
County: Brevard		Cell Phone:
Insurance Company:		Policy #:
Year of Home: 1991	# of Stories: 2	Email:

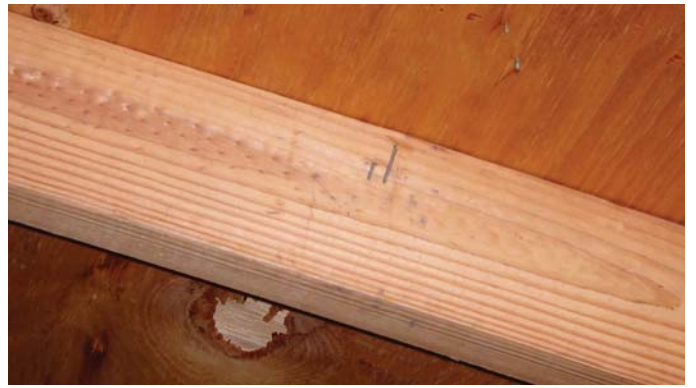
- A. Plywood/Oriented strand board (OSB) roof sheathing attached to the roof truss/rafter (spaced a maximum of 24" inches o.c.) by staples or 6d nails spaced at 6" along the edge and 12" in the field. -OR- Batten decking supporting wood shakes or wood shingles. -OR- Any system of screws, nails, adhesives, other deck fastening system or truss/rafter spacing that has an equivalent mean uplift less than that required for Options B or C below.

Staple

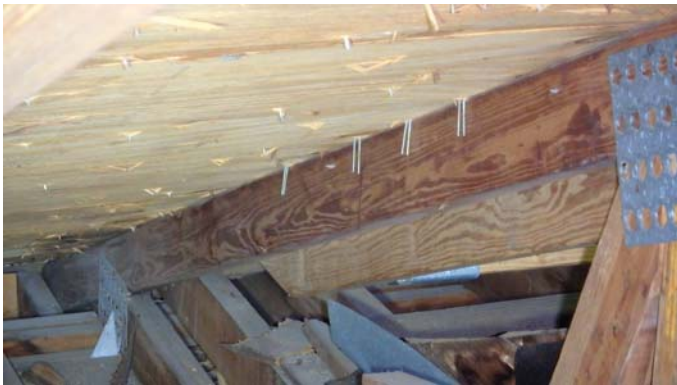
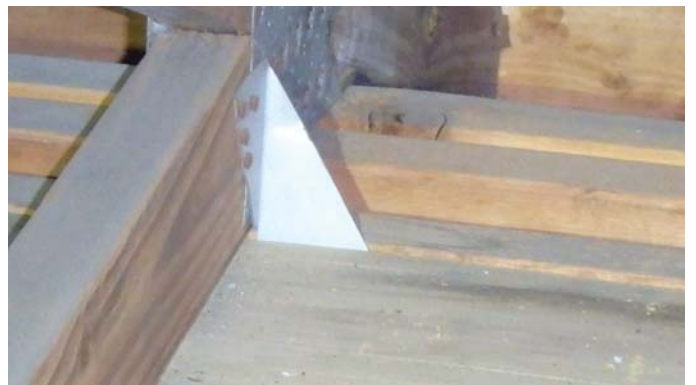
- B. Clips
 - Metal connectors that do not wrap over the top of the truss/rafter, **or**
 - Metal connectors with a minimum of 1 strap that wraps over the top of the truss/rafter and does not meet the nail position requirements of C or D, but is secured with a minimum of 3 nails.
- C. Single Wraps

Clip
