Maintain a copy of this form and any documentation provided with the insurance policy

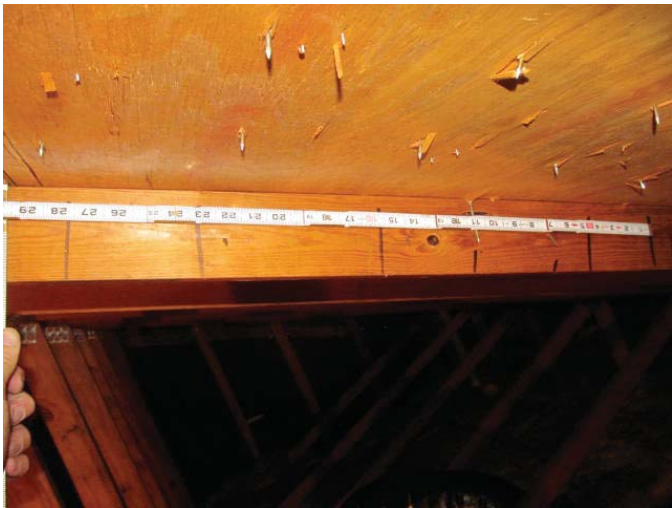
- Secured to truss/rafter with a minimum of three (3) nails, **and**
- Attached to the wall top plate of the wall framing, or embedded in the bond beam, with less than a 1/2" gap from the blocking or truss/rafter **and** blocked no more than 1.5" of the truss/rafter, **and** free of visible severe corrosion.

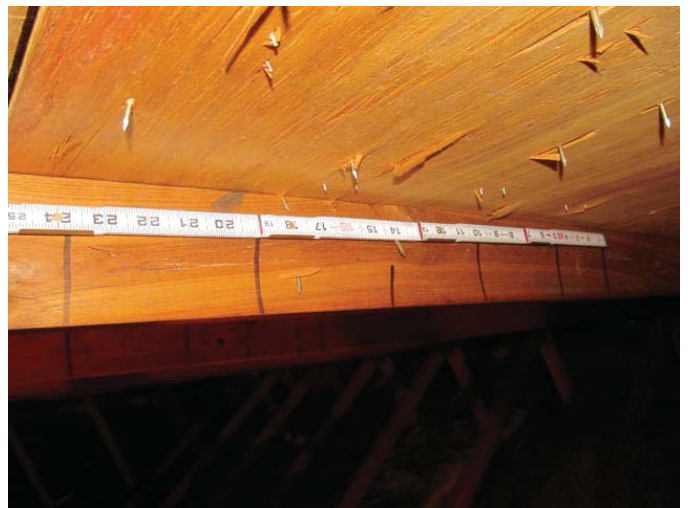
6. **Secondary Water Resistance (SWR):** (standard underlayments or hot-mopped felts do not qualify as an SWR)
