Maintain a copy of this form and any documentation provided with the insurance policy

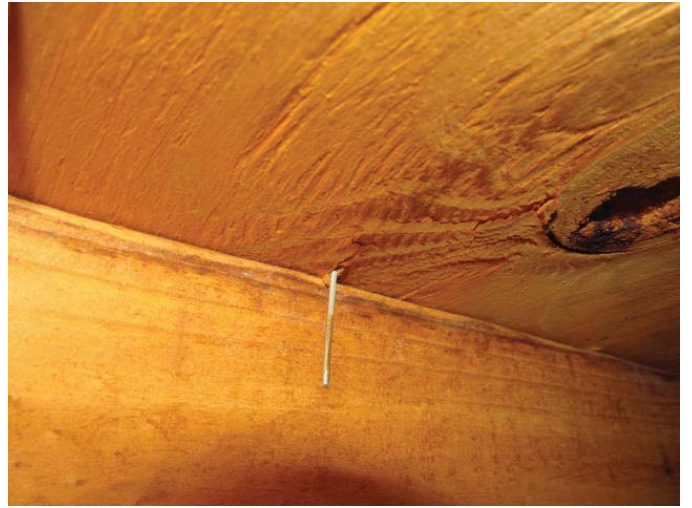
- A. Plywood/Oriented strand board (OSB) roof sheathing attached to the roof truss/rafter (spaced a maximum of 24" inches o.c.) by staples or 6d nails spaced at 6" along the edge and 12" in the field. -OR- Batten decking supporting wood shakes or wood shingles. -OR- Any system of screws, nails, adhesives, other deck fastening system or truss/rafter spacing that has an equivalent mean uplift less than that required for Options B or C below.

Staples

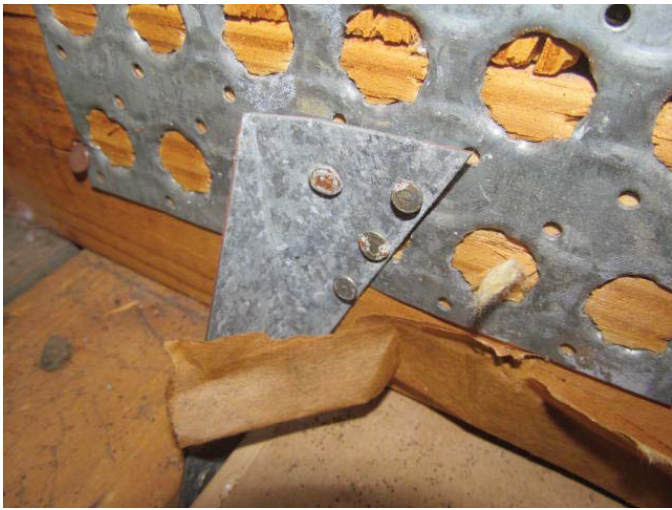
- B. Clips
 - Metal connectors that do not wrap over the top of the truss/rafter, **or**
 - Metal connectors with a minimum of 1 strap that wraps over the top of the truss/rafter and does not meet the nail position requirements of C or D, but is secured with a minimum of 3 nails.

Clips - with minimum three nails
