Maintain a copy of this form and any documentation provided with the insurance policy

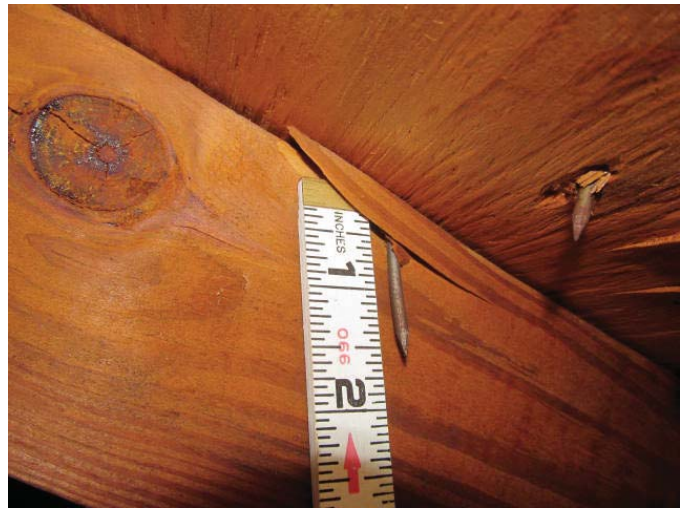
- Secured to truss/rafter with a minimum of three (3) nails, **and**
- Attached to the wall top plate of the wall framing, or embedded in the bond beam, with less than a 1/2" gap from the blocking or truss/rafter **and** blocked no more than 1.5" of the truss/rafter, **and** free of visible severe corrosion.
